HiRISE ENGINEERING, P.C.

| Subject: | Insured: | Mr. Harry Shlyonsky 229 Exeter Street Brooklyn, NY 11235 |

Conclusions:

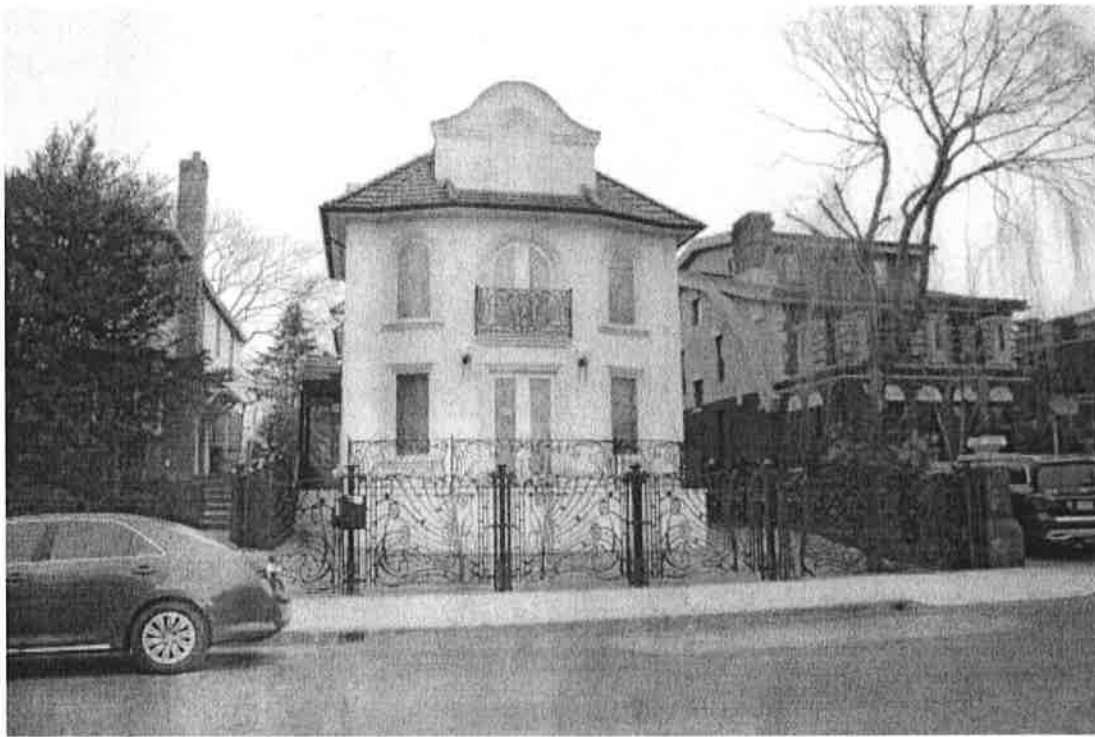
THE FRONT VIEW OF THE PROPERTY

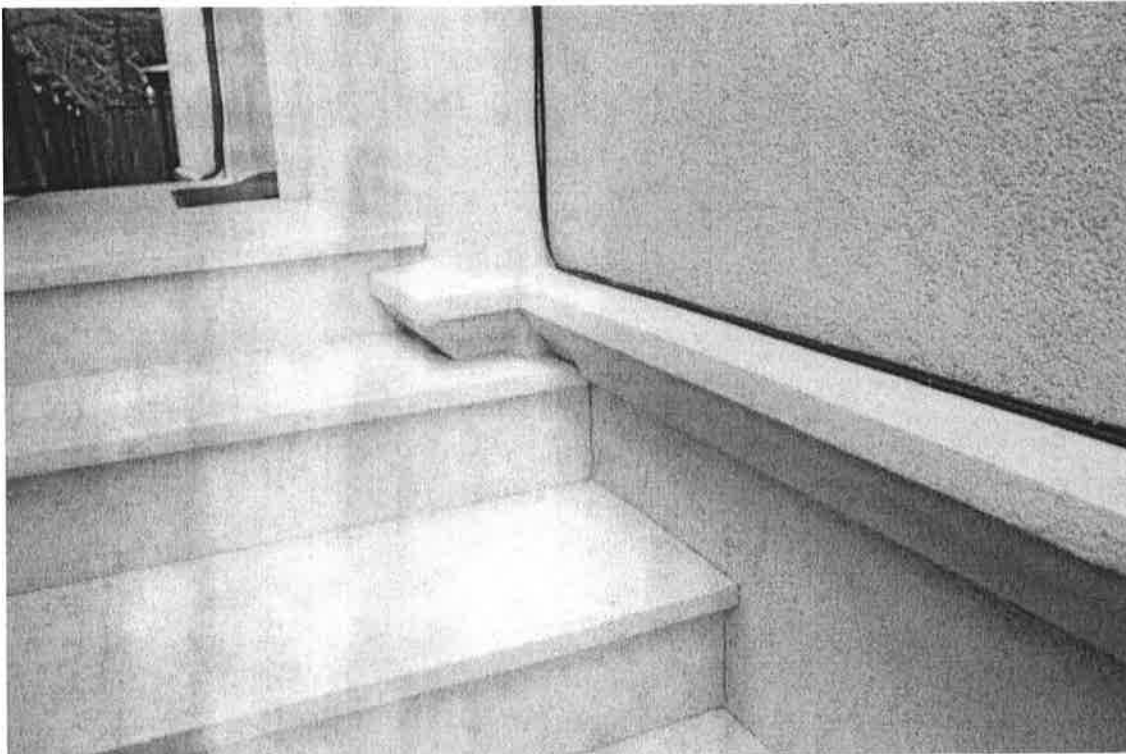
Spacing between the exterior stairs leading to the first floor and the cellar was noted between the treads and risers and the EIFS facades.

EXTERIOR STAIRWAY STEPS CRACKS

Spacing between the stone staircases and EIFS facades were pre-existing. There was no evidence to support that damage was caused by flooding.

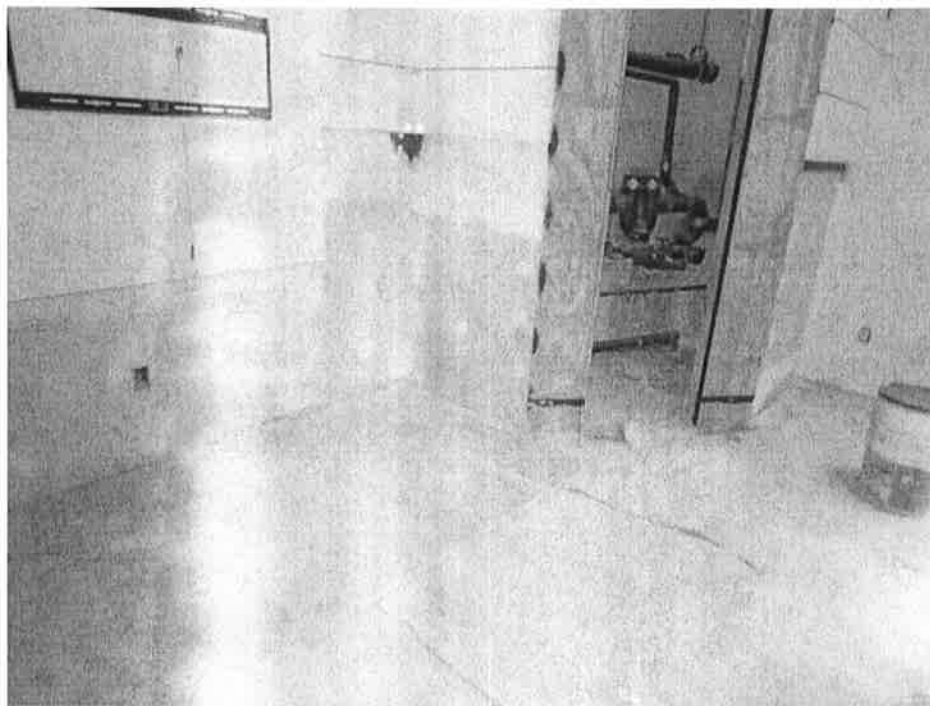
CELLAR AREA FINISHES DAMAGED UNDER ON GOING REPAIR

No flood-related structural damage to the building was found. Damages were limited only to finish materials such as drywall and flooring which were caused by saturation during the flooding. The water level line was at least 7' high in the cellar. Observation of all structural components of the dwelling revealed no damage.
